Our Ref: 16038
Morawa Aquatic Centre
Swimming Pool Core Survey

airey taylor consulting
engineers
scientists

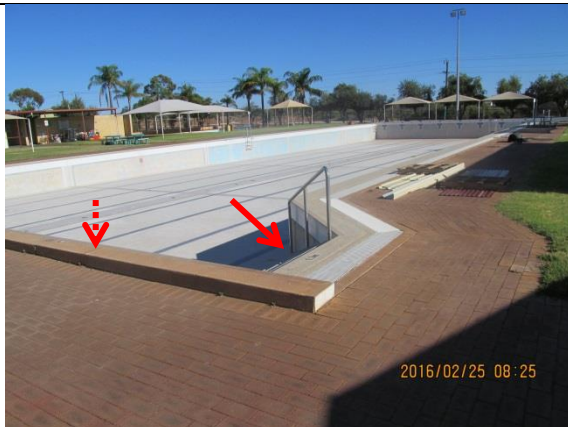
Figure 1: The south east corner of the pool (shallow end) showing the top of the stairs into the pool (solid arrow). The starter block is indicated by the dotted arrow.

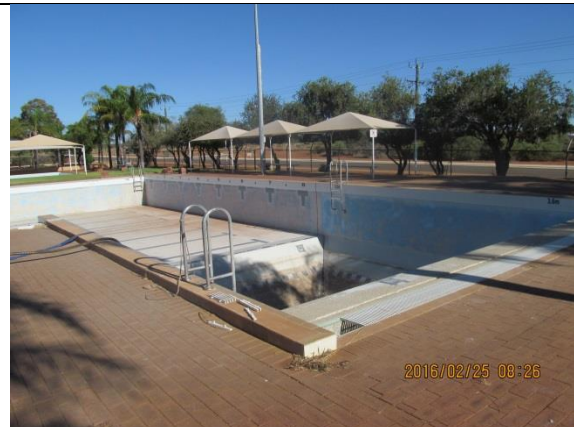
Figure 2: The dive pool area on the north east side of the pool.

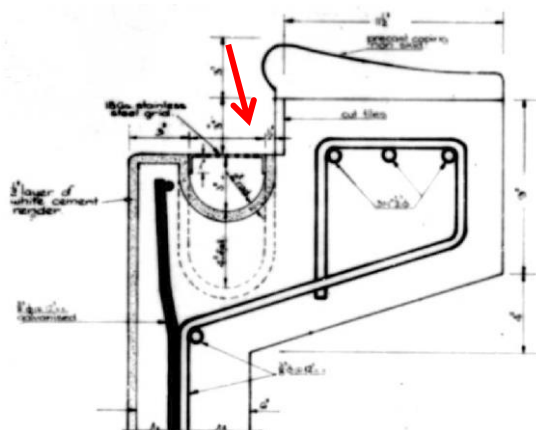
The drains on the side of the pool had been renovated sometime in the late 80's to early 90's. Figure 3 shows a detail of a drain from the pool drawings dated 1966 where the drain had been relatively close to the edge of the pool. As shown in Figure 1, the renovations involved sealing the top of the original drains and placing a new drain further away from the pool. A void was present behind the pool wall, seemingly beneath the old drain. The void was observed when extracting Core 7 and 13 (Figure 4 shows the void behind core 13). The wall was approximately 150 mm thick and the void was about 130 mm wide. The tiled concrete at the top of the pool wall and at least the shallow end wall did not appear to have a void since core holes at sites 2 and 5 did not have a void behind it.

Figure 3: A detail of drains on the side of the pool on drawings dated 1966.

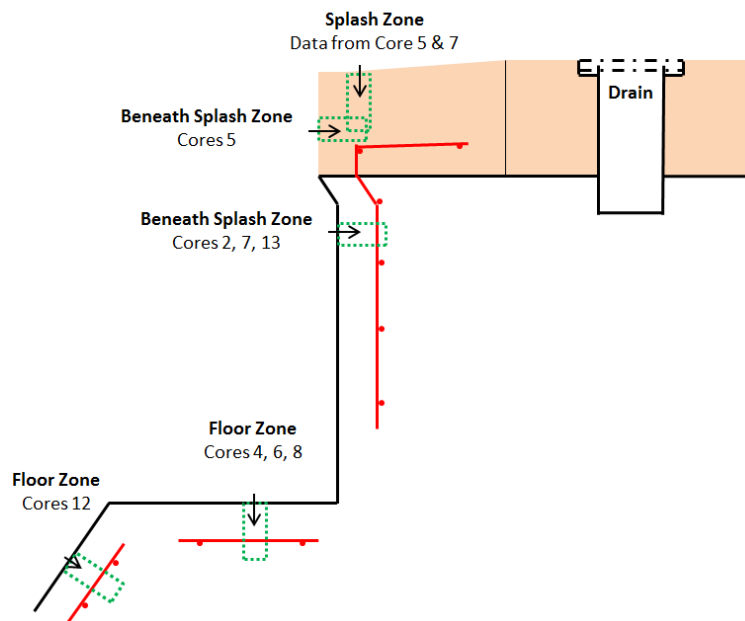
Figure 5: Schematic diagram of the approximate locations of each of the core samples with respect to the pool structure. The positioning of the reinforcement steel are also approximations from the observations during the GPR survey.

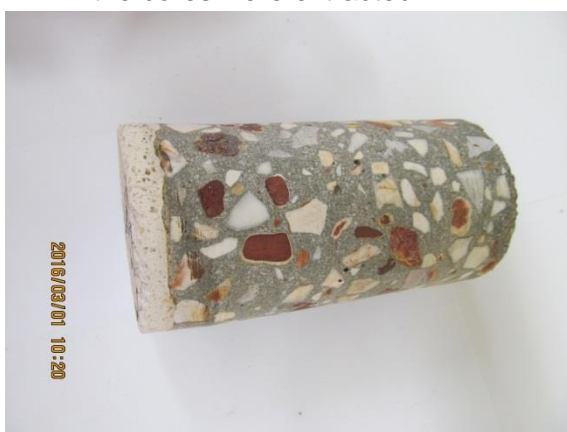
The concrete slab of the pool floor had multi-coloured aggregate particles with a white topping of varied thickness (Figure 6). At the tiled floor areas, there was the tile and an intermediate material on top of the concrete instead of the white topping (Figure 7). The cores taken from the main pool floor include Core 4, 6 and 8 while Core 12 was from the sloped surface of the dive pool. The soil was reached beneath Core 4 and 8 at approximately 145 mm depth. No void was observed on site when the cores were extracted.

Figure 6: Core 4 Floor sample showing the white topping over the concrete with multi-coloured aggregates.

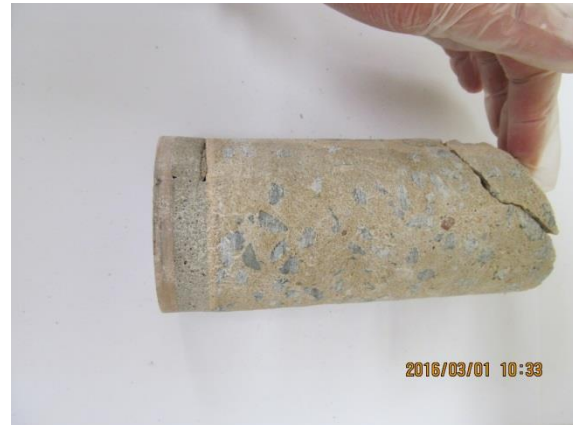
Figure 9: Core 5 Beneath splash zone was in the tiled area above the first horizontal reinforcement steel on the east side of the pool. A tile and intermediate layer is observed over concrete with blue aggregates and a different type of cement.

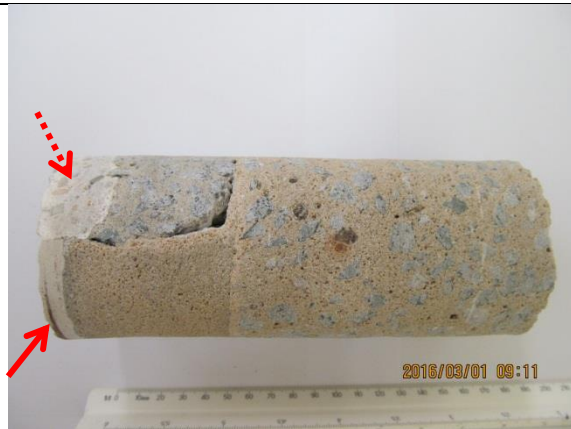
Figure 10: Core 1 Splash zone sample had both a tile (solid arrow) and a stone topping (dotted arrow) over the core. There is an intermediate material and concrete beneath the tile and stone topping respectively. A second type of concrete is observed beneath both.

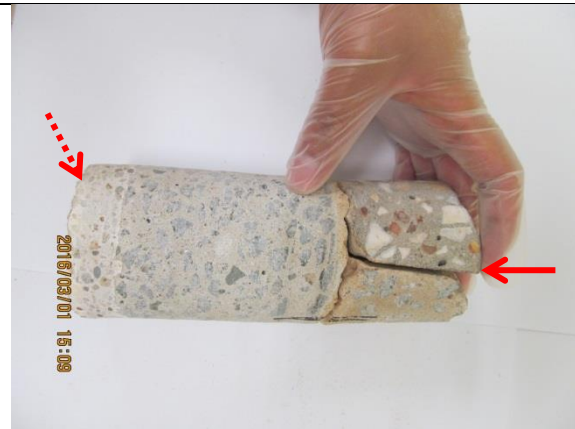
Figure 11: Core 11 Splash zone had the stone topping (dotted arrow) over the concrete. At a certain depth, two different concretes were observed (interface shown by solid arrow) beneath the first concrete material.

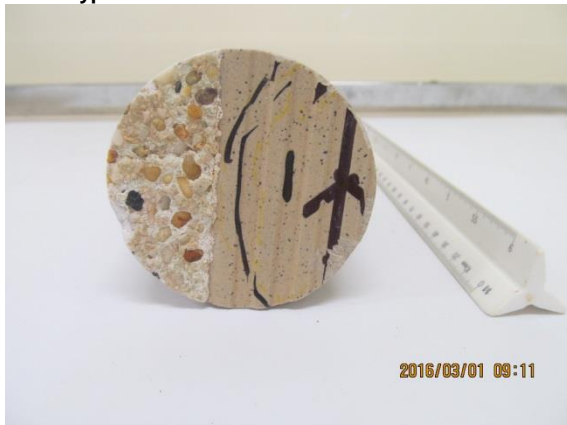
Figure 12: Core 1 Splash zone sample showing the tile and stone topping over the core.

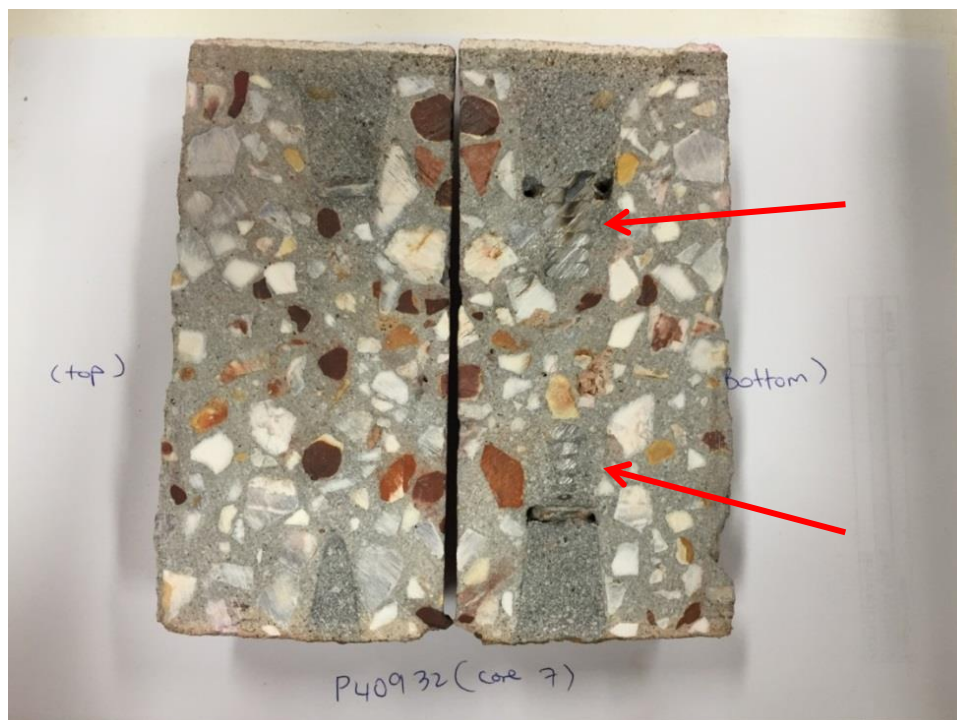
The High Cl Threshold (0.78 % Cl by weight of cement) represents the chloride concentration limit for all submerged zones (beneath the splash and floor core samples). Of the cores tested for chloride content within these zones, the shortest projected service life is 20 years (Core 5 Top half considering the projection when $C_s = 1.40$ % Cl by weight of cement). Core 7 bottom half (beneath the splash zone) had embedded reinforcement steel with no evidence of corrosion. Core 7 top half is projected for 50 years (when $C_s = 1.40$ % Cl by weight of cement). The lack of corrosion is therefore in agreement with the significant remaining service life at least for beneath the splash zone around Core 7.

Figure 14: Core 7 (beneath the splash zone) was found to have reinforcement steel within the bottom half of the core (as indicated by the arrows). No evidence of corrosion on the steel was observed.

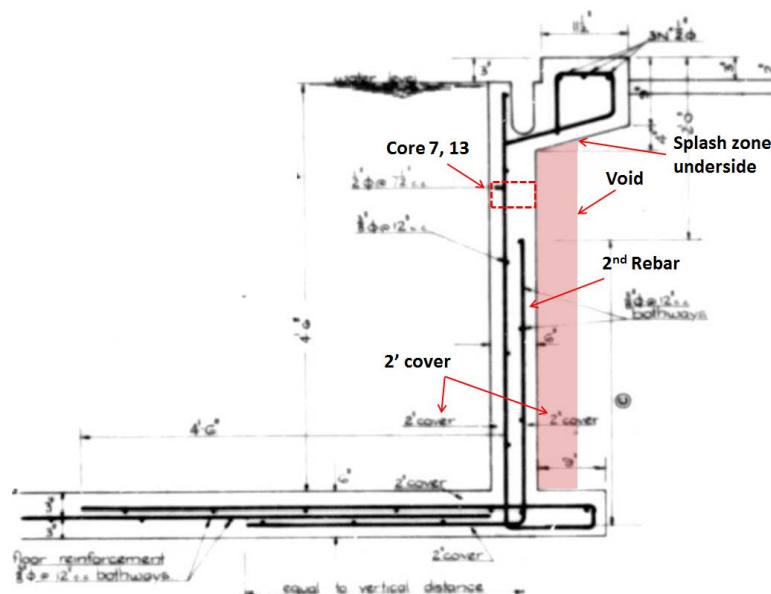
It must be remembered that the projections in Table 3 does not consider the presence of voids or air pockets on the other side of the concrete (soil side). As described in Section 2.1, a void was observed behind Core 7 and 13 (beneath the splash zone cores on the east and west sides of the pool respectively). A schematic showing the location of the void is shown in Figure 15. If the void was completely filled with air, all surfaces in contact with the void would be considered as splash zone surfaces. Core 13 is carbonated 10 mm on the void side according to the carbonation report (Appendix L), suggesting the air (at least on the west pool wall behind Core 13) is being replenished and the susceptibility to carbonation (ie. Corrosion of reinforcement) is increased.

Figure 15: A schematic detail of the pool wall showing the location of Core 7 and 13 with respect to the pool. The cover of rebar in the pool wall is 2 inches according to the drawings (approximately 50.8 mm) on both the pool side and the void side. The void is assumed to run along the whole length of the pool walls and the full height (as indicated in red).

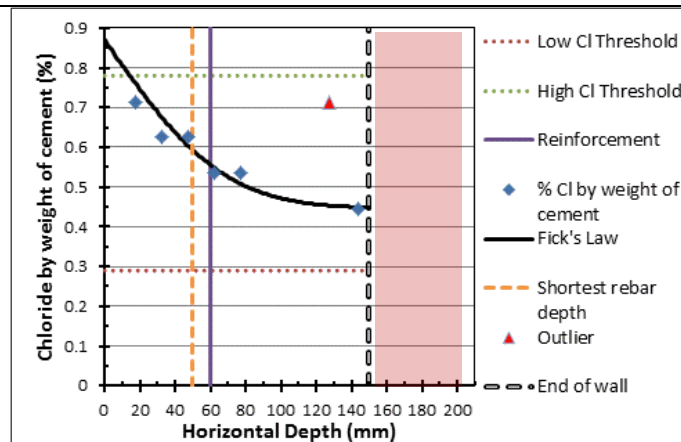
While Core 7 and 13 are beneath the splash zone samples on the pool, they would be considered as splash zone samples on the void side. Figure 16 shows the Fick's Law fit (% Cl by weight of cement) for Core 7. From the void side, the chloride concentration is greater than the Low Cl Threshold and therefore the reinforcement is expected to already be corroding. Although no corrosion was observed within Core 7 (Figure 14), corrosion may have initiated elsewhere along the void. Figure 15 shows a second layer of reinforcement within the pool wall closer to the floor with approximately 50.8 mm (2 inch) cover on the void side. With less cover on the void side the second layer of reinforcement (that on the void side) is more susceptible to corrosion.

Figure 16: Fick's Law fitting (% Cl by weight of cement) for Core 7 top half. Classified as a beneath the splash zone core from pool side and therefore below the High CI Threshold (green dotted line). From void side, it is a splash zone and had exceeded the Low CI Threshold (red dotted line). The void is highlighted in red.

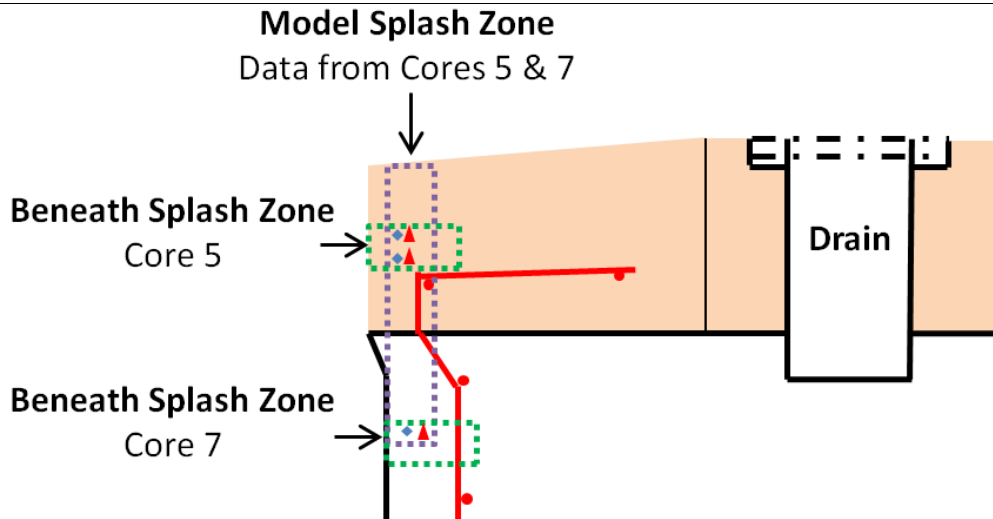
Figure 17: Schematic showing the location of Core 5 and 7 with respect to the pool wall (dotted green line). The purple dotted line represents the model splash zone core being represented by the select chloride concentration data from both Core 5 and 7. The blue set of data is from the 60-75mm increment of Core 5 (top and bottom half) and the 55-70mm increment from Core 7. The red set of data is from the 75-90mm increment of Core 5 (top and bottom half) and the 70-85mm increment from Core 7.

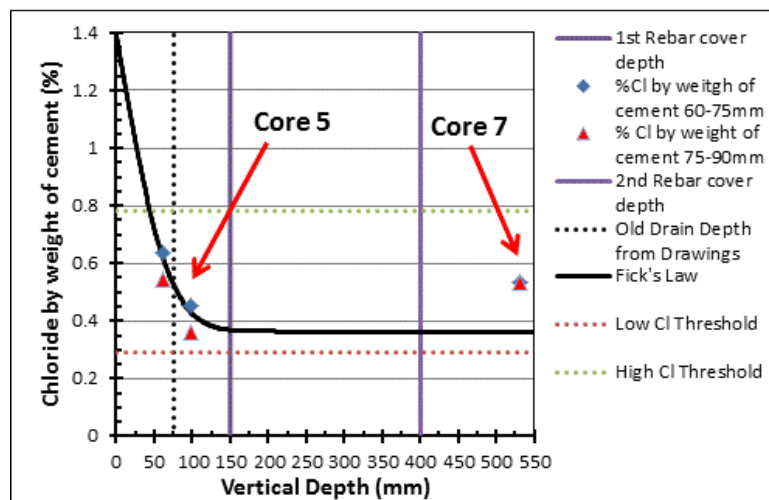
Figure 18 shows this data fitted with Fick's Law. All data points were greater than the Low CI Threshold, therefore would have a projected service life of 0 years (since it is considered as a splash zone). There appeared to be a decreasing gradient of chloride content from the top half to the bottom half of Core 5. Deeper in the model core, the data from Core 7 was greater than the expected chloride content according to Fick's Law. It is not clear why this is the case as there are a number of factors which can influence the chloride content in Core 7. This includes the presence of a void behind Core 7 and the pool side surface of Core 5 was tiled as compared to the rendered surface of Core 7. Nevertheless, the exceedance of the Low CI Threshold is in agreement with the splash zone Cores 1 and 9, which are all adjacent to the pool wall.

Figure 18: Fitting Fick's Law for the chloride concentration data for Core 5 and 7. The blue set of data is from the 60-75mm increment of Core 5 (top and bottom half) and the 55-70mm increment from Core 7. The red set of data is from the 75-90mm increment of Core 5 (top and bottom half) and the 70-85mm increment from Core 7.
