**AUDIT AND RISK MANAGEMENT
COMMITTEE**

Thursday, 19 November 2020

Old Morawa Hospital
Asbestos Report
14 October 2020

Shire of Morawa

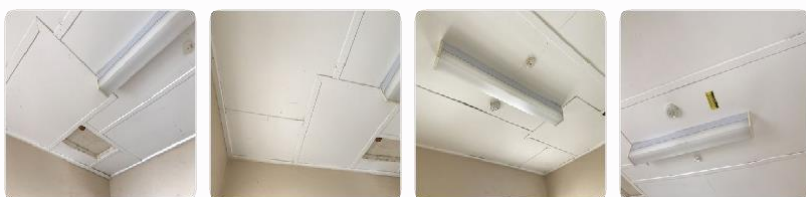
Photo 25 Photo 26 Photo 27 Photo 28

Date and time of Inspection	1st Sep, 2020 1:59 PM AWST
Describe location of the ACM/Presumed ACM Store - ceiling panels and batons

Asbestos Containing Material	ACM suspected
Material type	Hardiflex sheeting
Condition	Good
Details on Condition: Painted, sealed and intact	
Quantity sqm (apx)	10
Friable or Non-Friable	Non-Friable
Is this an inaccessible area?	Only accessed by maintenance staff / contractors

Monitor for wear and damages
