Our Ref: 16038
Morawa Aquatic Centre
Swimming Pool Core Survey

airey taylor consulting
engineers
scientists

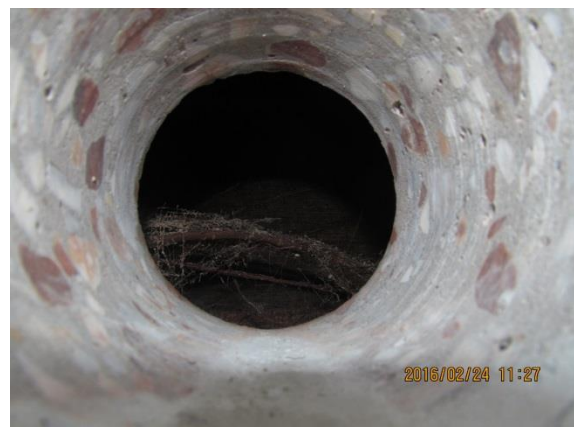
Figure 4: Core hole 13 (Beneath the splash zone) with a void at approximately 150 mm from the surface of the pool wall.

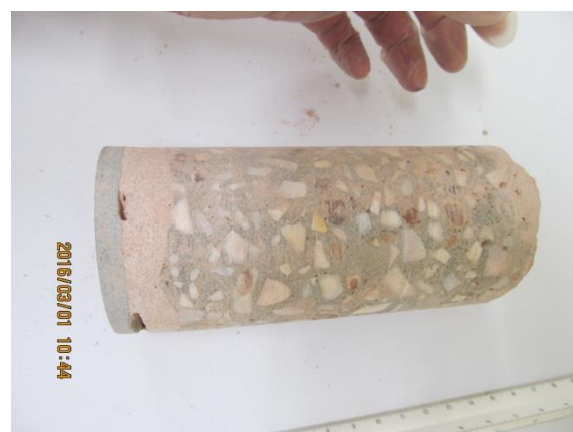
The concrete slab of the pool floor had multi-coloured aggregate particles with a white topping of varied thickness (Figure 6). At the tiled floor areas, there was the tile and an intermediate material on top of the concrete instead of the white topping (Figure 7). The cores taken from the main pool floor include Core 4, 6 and 8 while Core 12 was from the sloped surface of the dive pool. The soil was reached beneath Core 4 and 8 at approximately 145 mm depth. No void was observed on site when the cores were extracted.

Figure 7: Core 6 Floor with a tile and intermediate material over the concrete and multi-coloured aggregates. The orange colour of the core is debris from drilling that had dried onto the core surface.

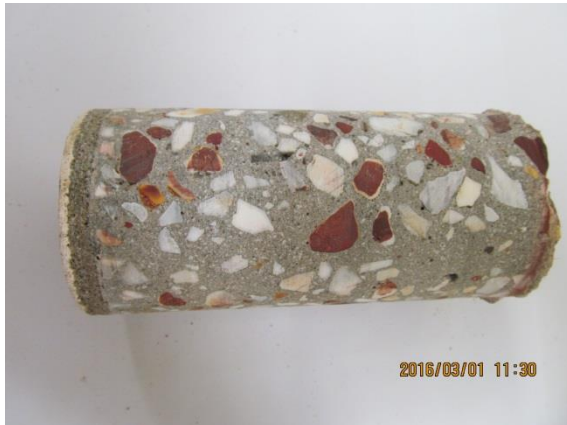
The cores taken from the pool below the tiles that line the lip of the pool typically had the white topping and intermediate layers covering concrete with multi-coloured aggregate particles (an example is Core 7 shown in Figure 8). These cores included Core 2, 7 and 13. Cores taken within the tiled area at the lip of the pool wall had a tile and intermediate layer covering concrete with blue coloured aggregate particles and a different type of cement (Core 5 shown in Figure 9).

Figure 8: Core 7 Beneath splash zone sample showing the white topping and intermediate material over the concrete with multi-coloured aggregates.

Core 13 was a beneath splash zone core, extracted from the west pool wall and had a carbonation depth of 10 mm on the bottom side. Core 7 is beginning to carbonate at both the topping and bottom face as the pink colouring from the phenolphthalein spray was lighter than the rest of the core. However as a pink colour was still observed, no carbonation was reported on the laboratory report (Appendix L). All other beneath the splash zone cores (Cores 2 and 5) had no carbonation observed.

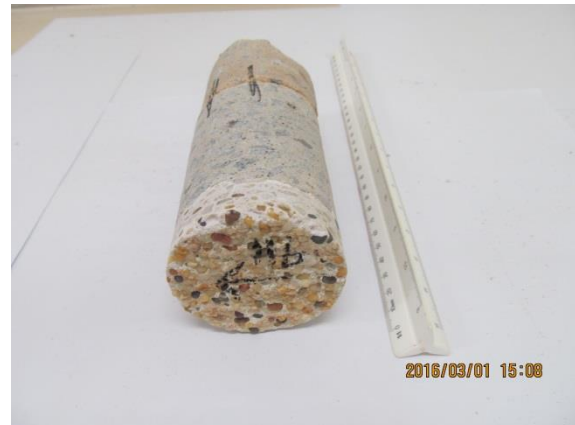
Core 11 (Figure 11) only had the stone topping on top of the concrete (shown in Figure 13) however, at a certain depth, there were two types of concrete which is different to the concrete above (solid arrow in Figure 11).

Figure 13: Core 11 Splash zone sample showing only the stone topping over the core.

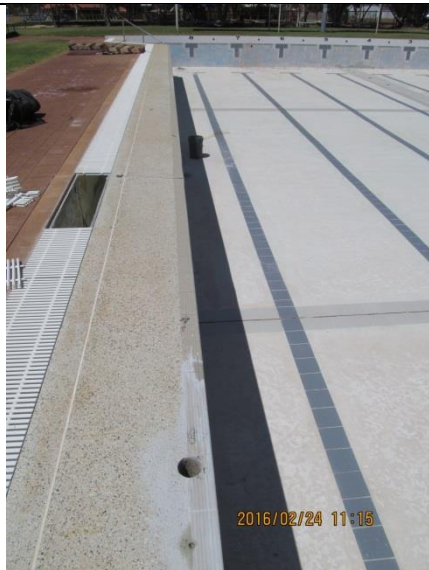
Figure B.7: The core hole at Location 1 on the east side of the pool.

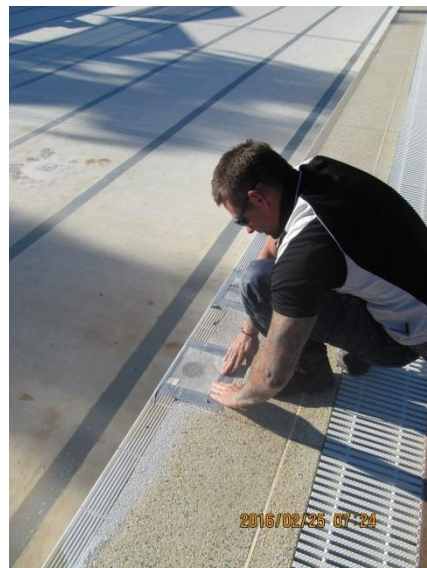
Figure B.46: Repaired core hole 10 taped over with polythene sheet.

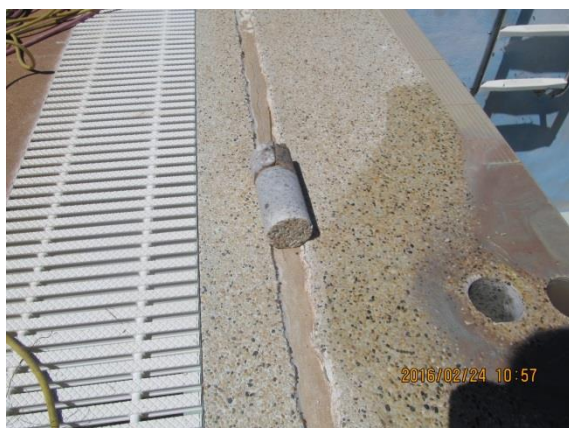
Figure B.47: The core hole at Location 11 on the east side of the dive pool.

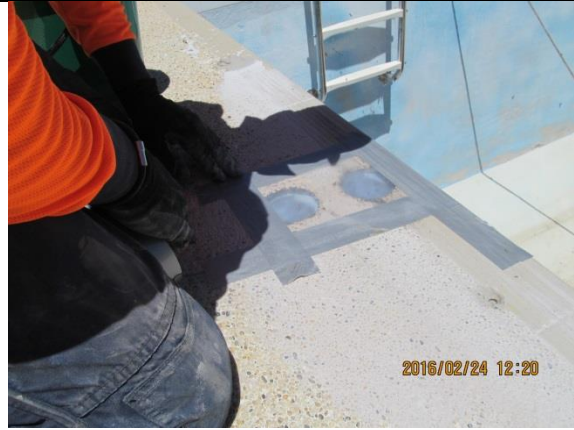
Figure B.50: Repaired core hole 11 taped over with polythene sheet.

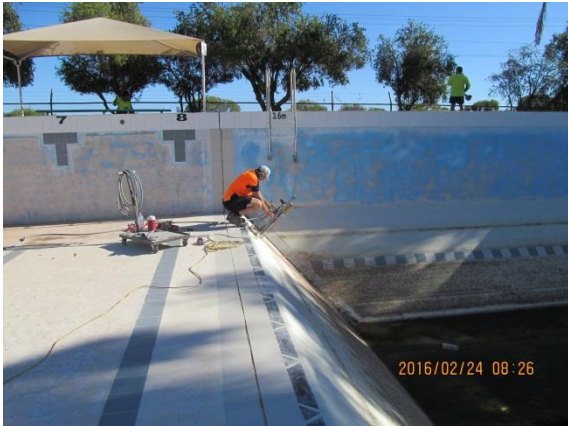
Figure B.51: The core hole at Location 12 on the sloped floor of the dive pool.

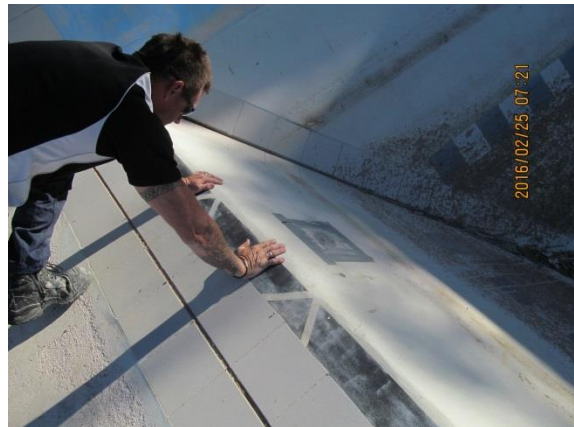
Figure B.54: Repaired core hole 12 taped over with polythene sheet.

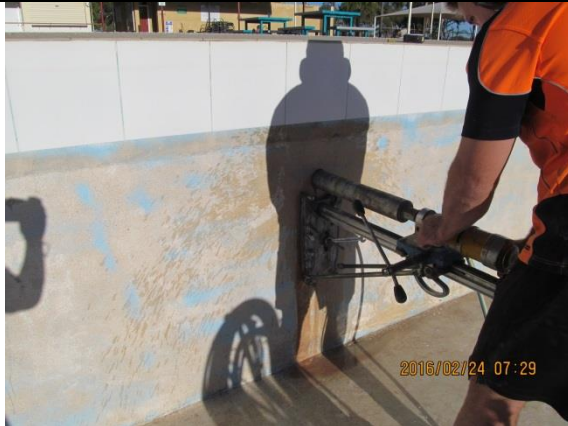
Figure B.55: The core hole at Location 13 on the west side of the pool.

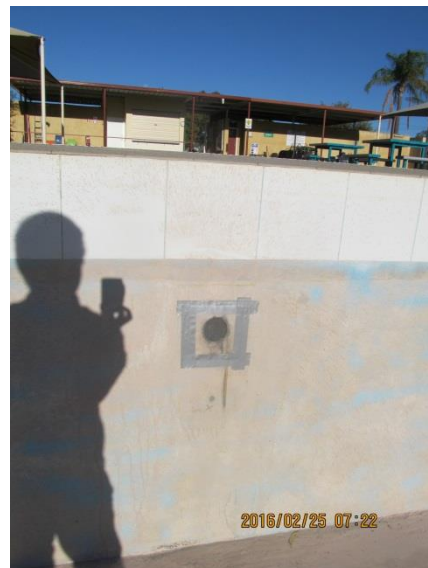
Figure B.58: Repaired core hole 13 taped over with polythene sheet.
