**AUDIT AND RISK MANAGEMENT
COMMITTEE**

Thursday, 19 November 2020

Old Morawa Hospital
Asbestos Report
14 October 2020

Shire of Morawa

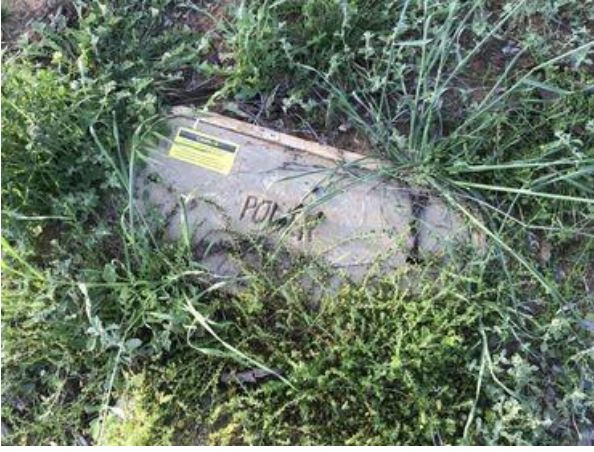
Photo 17

Asbestos Containing Material	ACM suspected
Material type	Other
Details: Power/ Telstra style pit	
Condition	Fair
Details on Condition: Deteriorating	
Quantity sqm (apx)	1
Friable or Non-Friable	Non-Friable
Is this an inaccessible area?	Accessible: potential to be damaged
Actions for consideration:	<ul style="list-style-type: none"> Consider safe removal & replace with non ACM Consider enclosing the ACM through non ACM disturbance measures Consider sealing the ACM appropriately Monitor and Review the ACM's condition Consider safely sampling the ACM for verification Signify ACM present

Remove vegetation away from pit, remove and replace with non ACM product
