Our Ref: 16038
Morawa Aquatic Centre
Swimming Pool Core Survey

airey taylor consulting
engineers
scientists

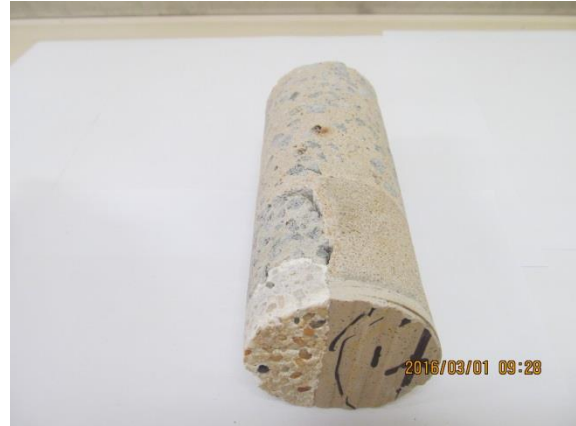
Core 4 yielded the highest cement content as it had the lowest aggregate: cement ratio compared to the other cores tested. In contrast, Core 1 had the lowest cement content as it was observed to have a significantly greater number of aggregates compared to the other cores (eg. Observations of aggregate density, Appendix C) revealed the presence of 126 individual aggregates between 5-10 mm in size).

Figure B.8: Photograph of Core 1.

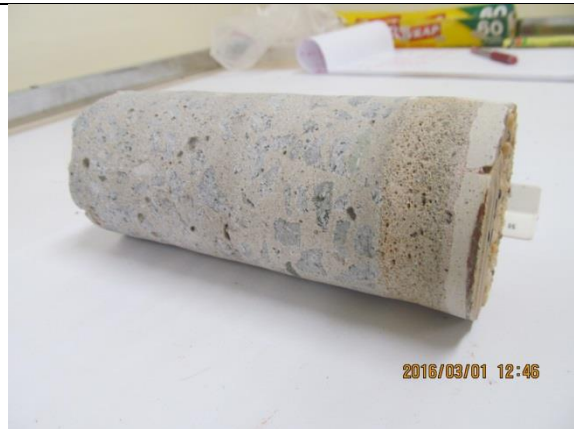
Figure B.44: Photograph of Core 10b.

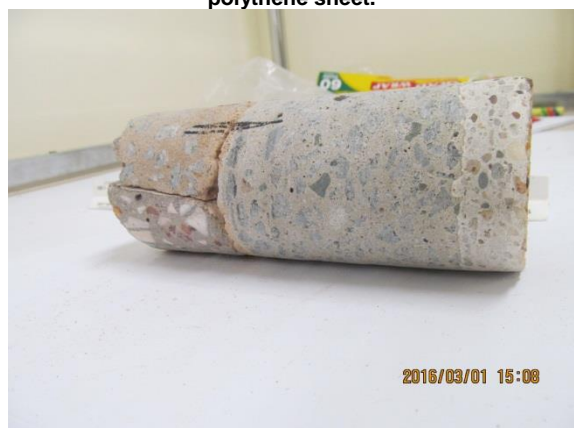
Figure B.48: Photograph of Core 11.

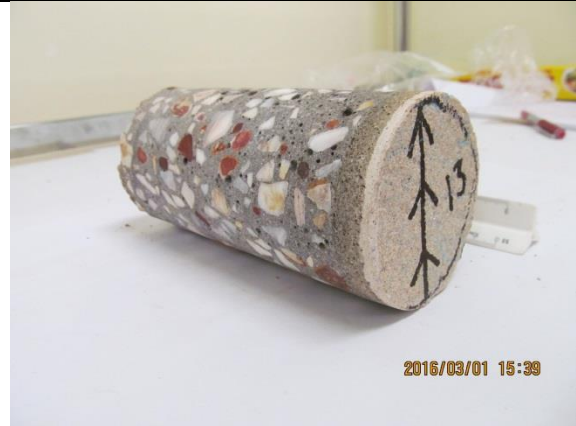
To confirm this, calculations for determining the k constant from Equation 2 were performed and presented in Table 5 by assuming d (mm) = carbonation depth and t = 47 years. The back side of Core 13 was found to be in an exposed environment which is in agreement with the assumption that surfaces in contact with the void are considered to be splash zone concrete.

Figure B.56: Photograph of Core 13.

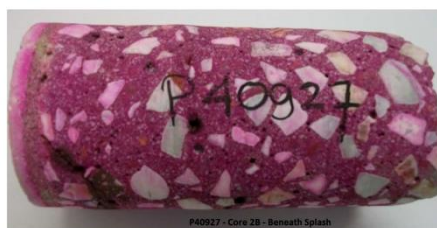
SGS Lab No.: P40927
Client No.: Core 2B, Beneath Splash – Beneath shallow end starter block
Length of Core: 145 mm
Type of Core: Partial Core
Depth of Carbonation: 0 mm in all layers

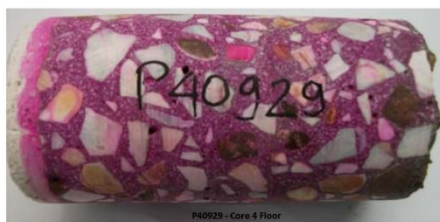
Length of Core: 145 mm

Depth of Carbonation: Topping: 6-8 mm, Topping/Concrete Interface: 0 mm

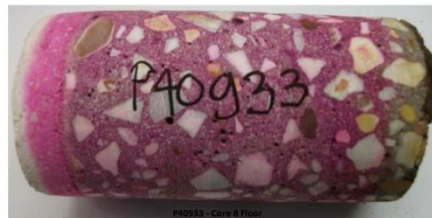
SGS Lab No.: P40933
Client No.: Core 8, Floor – Deep End
Length of Core: 140 mm
Type of Core: Through section core
Depth of Carbonation: Topping: 4-7 mm, Topping/Concrete Interface: 0 mm, Bottom Face: 0-7 mm

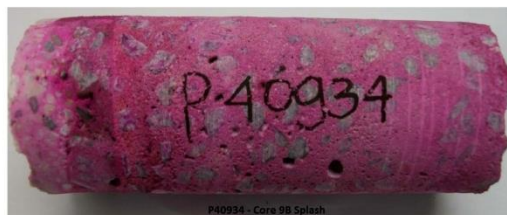
SGS Lab No.: P40934
Client No.: Core 9b, Splash – Middle West side of pool
Length of Core: 170 mm
Type of Core: Partial Core
Depth of Carbonation: 0 mm in all layers

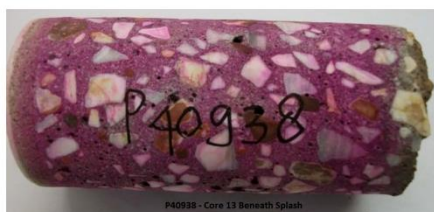
Type of Core: Through Section Core

Depth of Carbonation: Topping: 0 mm, Topping/Concrete Interface: 0 mm, Bottom Face: 0-10 mm
